**Project:** Narrows Bridge Piling

**Client:** Leighton Contractors

**Contractor:** Marine & Civil

**Year:** 2005

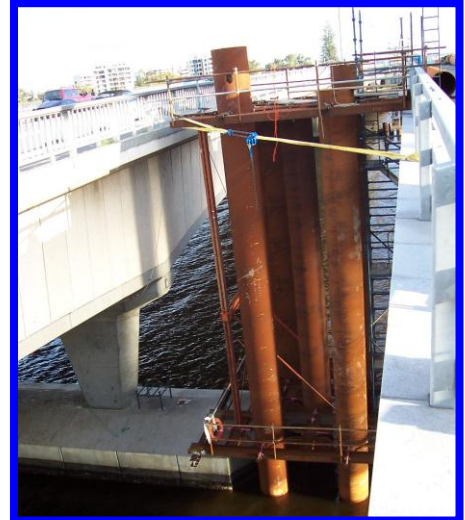
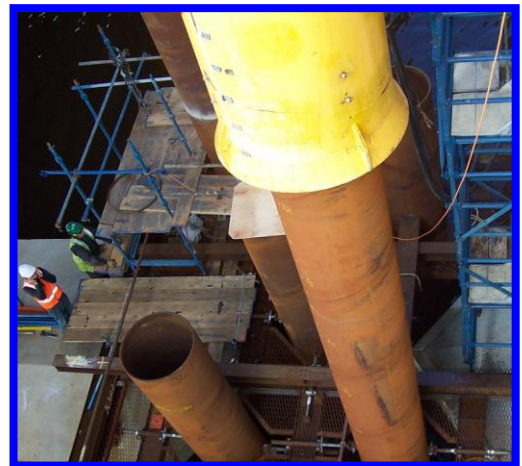
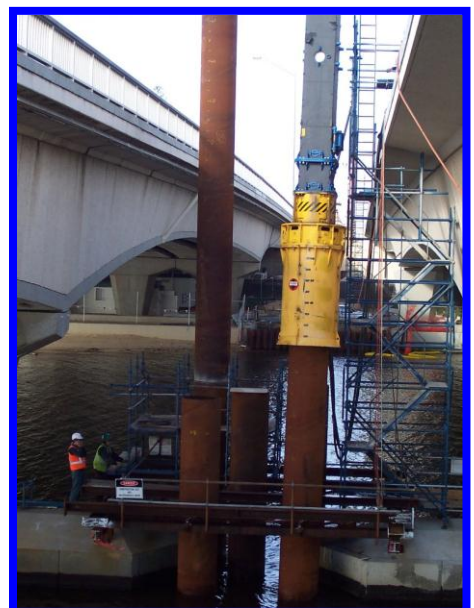
The pile gates were assembled at two levels to hold the piles in position whereby significant sideways forces were exerted during driving. At the bottom level the gates were anchored to the existing pilecaps. On the top level the gates were anchored to the newer existing bridge on one side and propped off the pile cap on the other side.

The pile gates had to be designed to account for the existence of timber piles below seabed that were used as temporary works for the construction of the initial bridge. The frequency, location and angle of these piles was unknown and the pile gates were fabricated with enough tolerance to re-position the piles if necessary.
